M/F COLUMBUS

Vessel inspection report and Deck strength assessment

210500.01.3042.01

Date 08.02.2022
Sign TCA

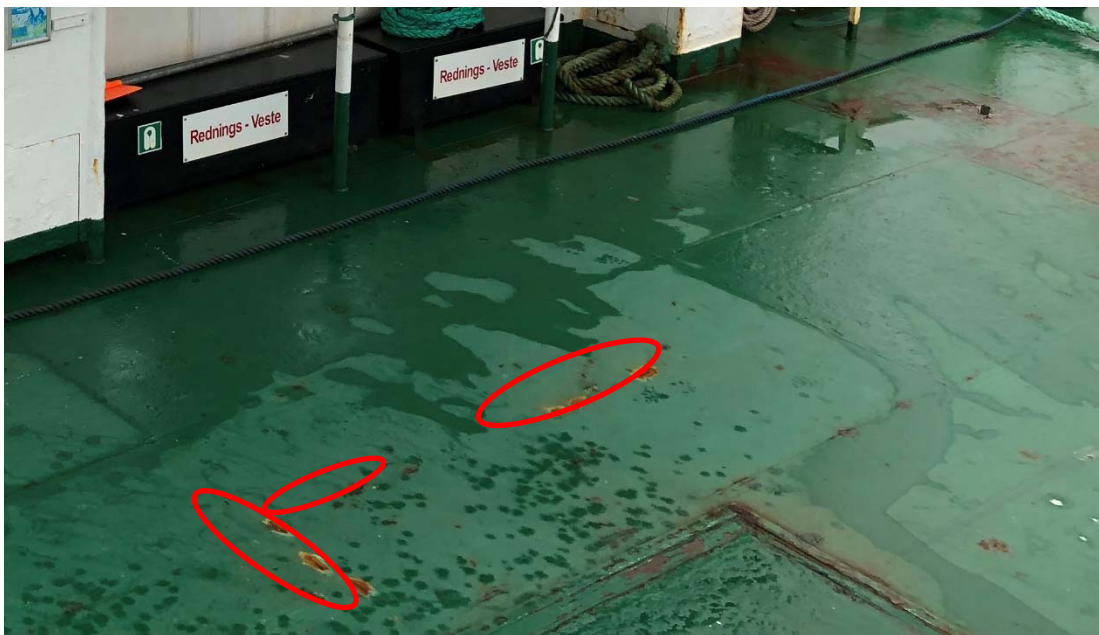
The top deck plating is attached to the flatbars with few slot welds. Some of the welds can be seen from above deck, where the coating has failed locally (see Figure 2).

Figure 2 - Slot welds, visible from above deck

-Where the original deck plating has been cut out, the top plate can be welded to the vertical flatbar with chain weld. This will improve the connection between plate and stiffener, and minimize the failure of the slot welds.

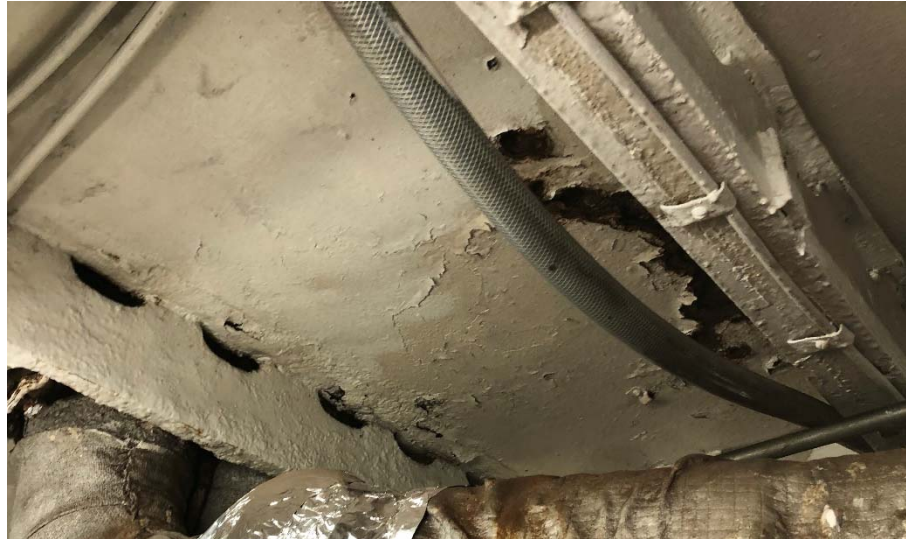
The original deck plating is fully coated from the engine room side. Many irregularities can be seen under the coats of paint, indicating that the plating and old coating was not properly treated before applying new paint.

Figure 3 - Example of poor condition of coating below original deck plating

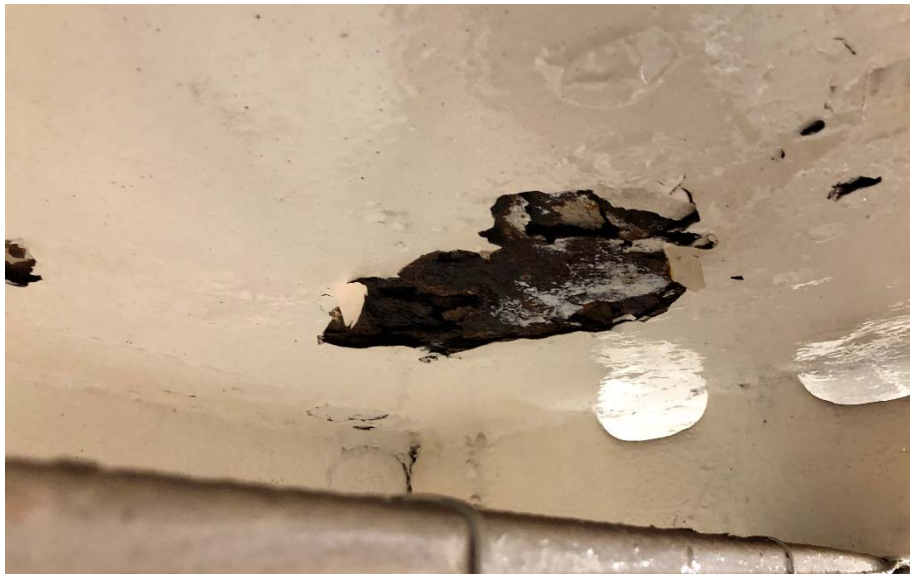
It is also possible to identify several holes through the deck plating (see Figure 4 and Figure 5).

Rust has been developing on the original deck plating, from the upper side, resulting in holes.

Figure 4 - Typical state of original deck plating, with irregularities and holes

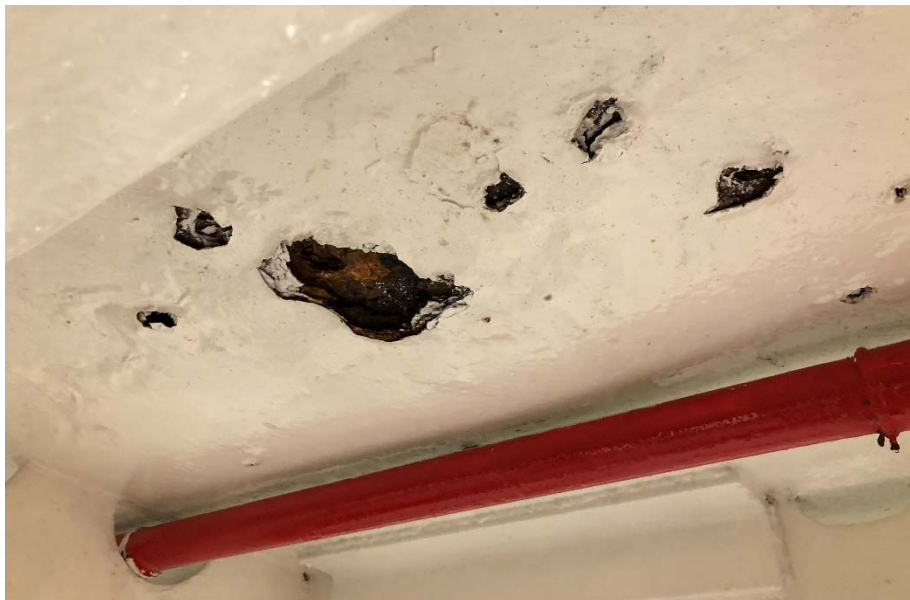
By inspection the holes and tapping the area around, it can be concluded that the flaking is not a local phenomenon.

Figure 5 - Original deck plate field with multiple holes and flaking of steel plate

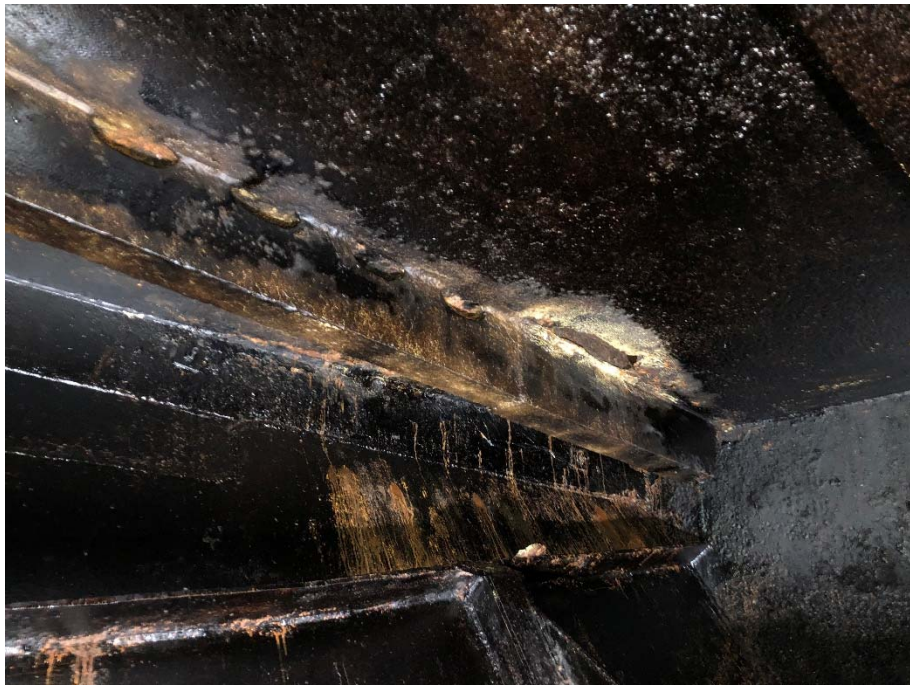
Figure 6 - Typical state of original deck plating in FWD void space

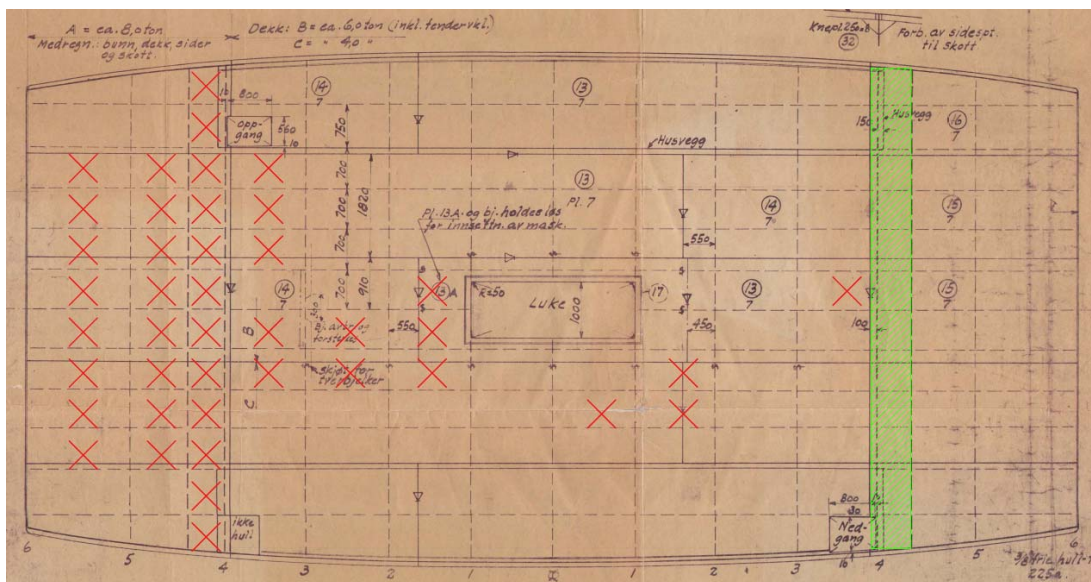
Over the last years (5-10 years), some of the original plating has been removed. This has been done in the areas with higher levels of corrosion in the original deck plating. Figure 7 highlights the areas that have been cut (red). In these areas, it is possible to see the top deck plating.

Figure 7 also highlights the area belonging to the top of the MDO tank in green. The plating in this area was replaced in February 2020.

Figure 7 - Overview of cut outs in original deck plating (Red) and replaced original deck plating (green)

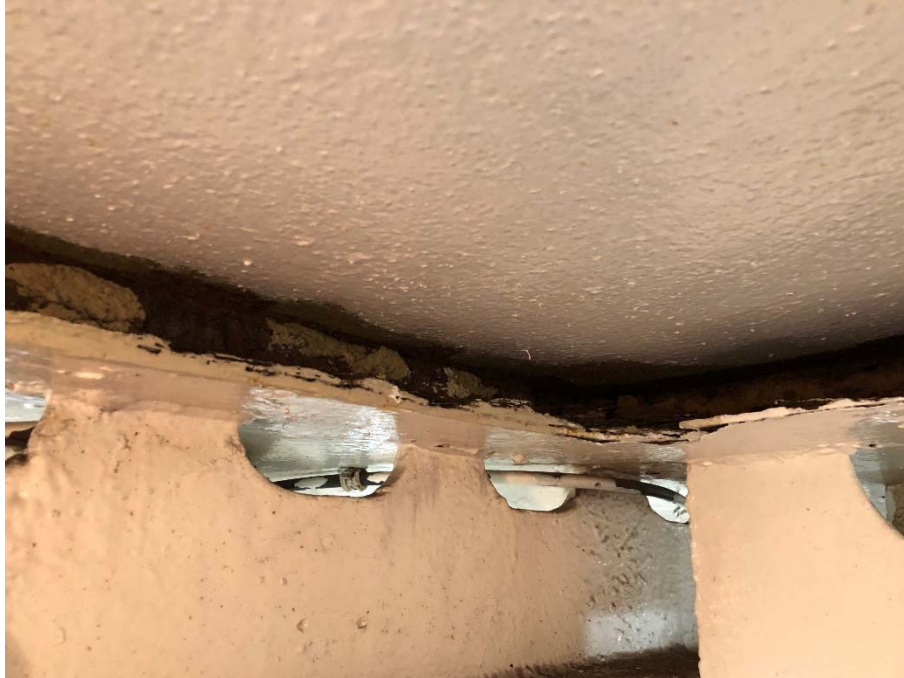
Upon inspection of the top deck plating via the openings in the original deck plating, it can be stated that the top deck plating presents a low level of corrosion.

The condition of the top plate seems to be the same across all the openings. Therefore, it is fair to assume that the top plate hidden by the original plate presents a similar low level of corrosion.

Figure 8 - Top deck plating seen through opening in original deck plating

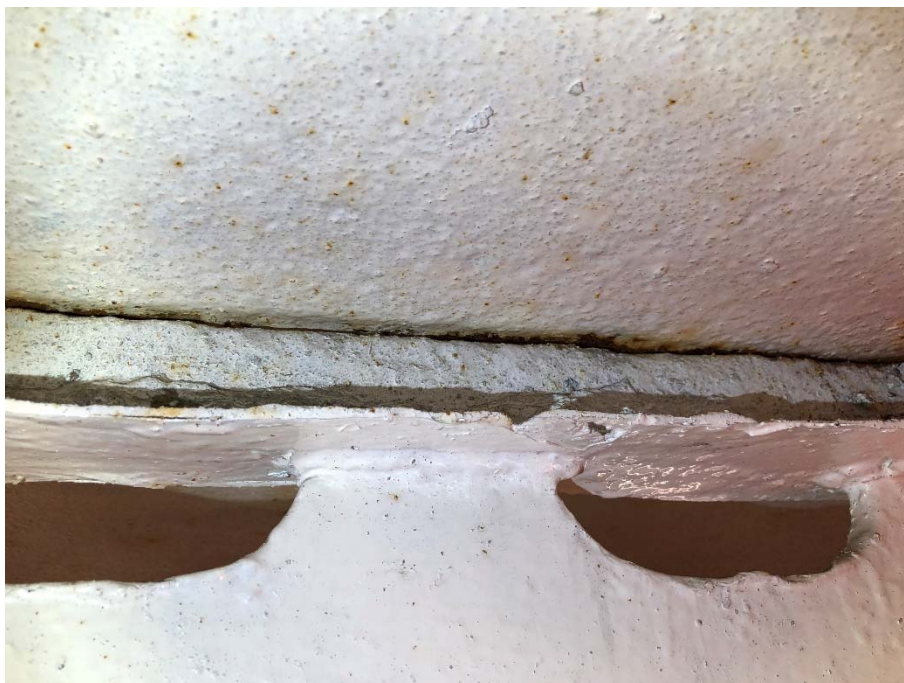
Figure 9 - Support of top deck plate

Figure 9 shows the typical connection. Since the plate is just resting on top of the flatbars, it is prone to slide and rotation from side to side as the vehicle weight is applied to the plate. This movement seems to have cause a slight abrasion on the plate surface.

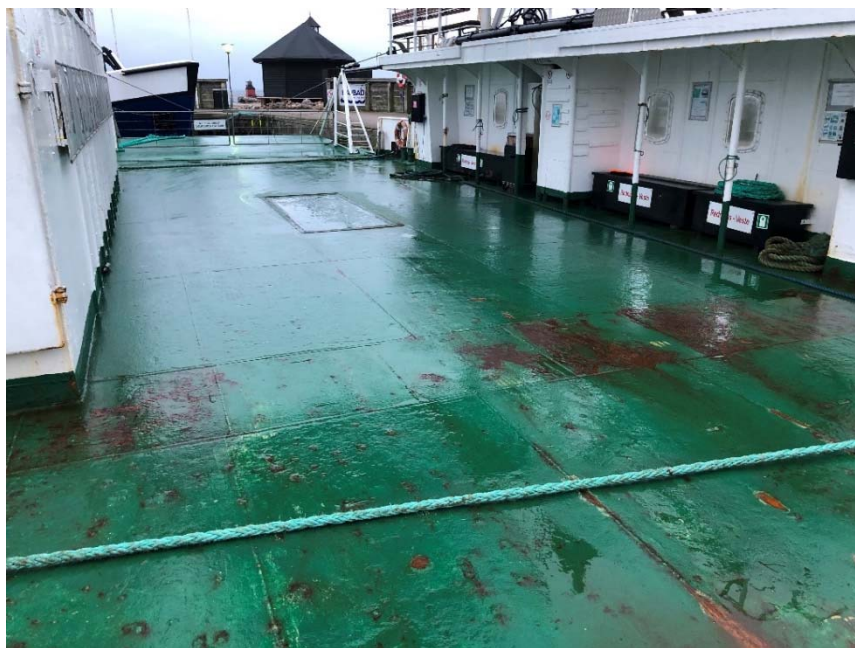
The rusted area in Figure 10 corresponds to the top decking plate replaced 2 years ago (February 2020), in connection with the replacement of the MDO tank top plating.

This indicates that the coating was not correctly applied in this particular area.

Figure 10 - Condition of top deck plating

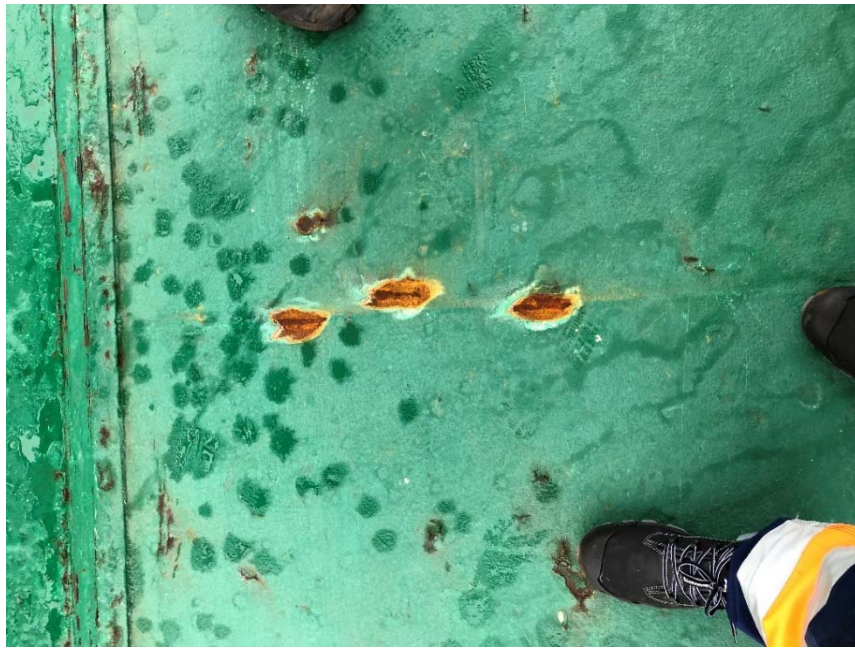
Figure 11 - Failure of coating system in way of slot welds

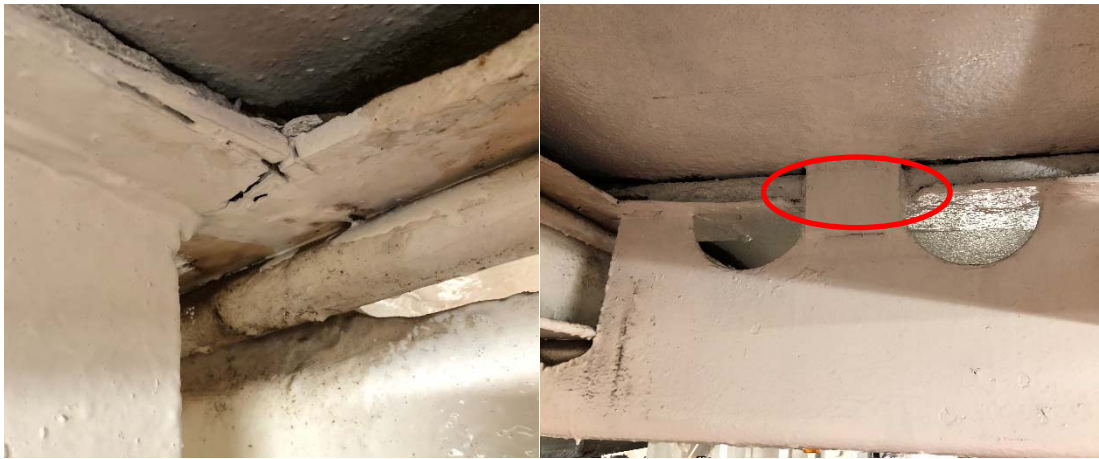
- severe corrosion and flaking of the original base plate;
- where the original plate has been removed, there is almost no plate left, and in some areas it is not continuous. Figure 14 shows a detail where the opening was overcut.

Figure 14 - Typical details of cut outs: intersection of stiffener and frame (left), web frame with plate missing (right)

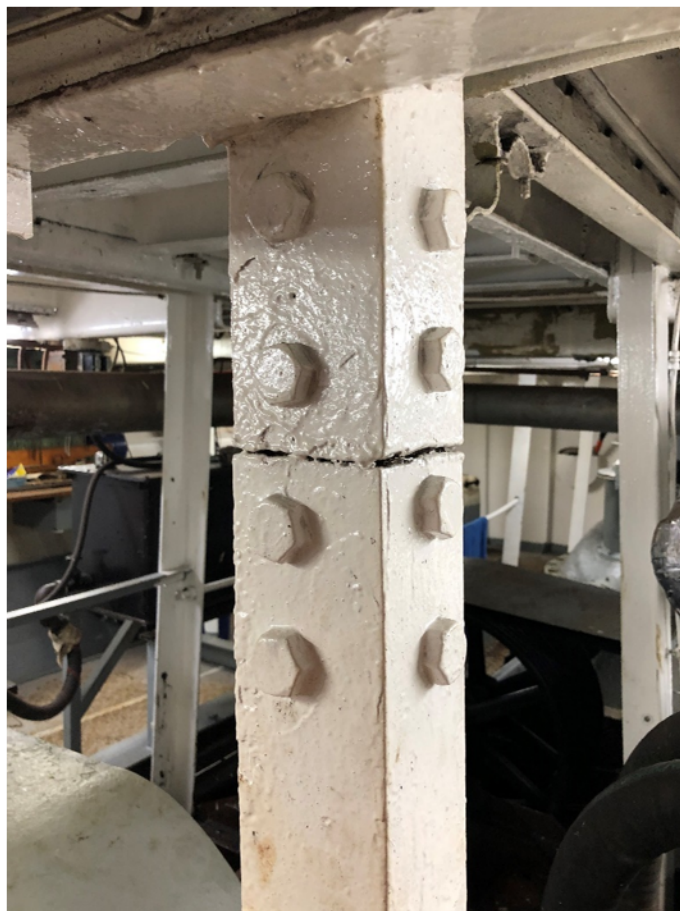
The only remark is that some of the pillars have been cut and joined by a lap bolted connection (see Figure 19).

These connections are present in the following 4 of the pillars:

- Frame #-3, Pillar 700 mm from CL (PS)
- Frame #-2, Pillar 700 mm from CL (PS)
- Frame #-1, Pillar 700 mm off CL (PS & SB)

It is believed that these modifications to the pillars were made when the main engines were replaced.

Figure 19 - Pillar bolted connection

The calculation for the bolted connection is shown in Table 3. The maximum utilization of the bolted connection under the assumptions above is **0.66** and considered acceptable.

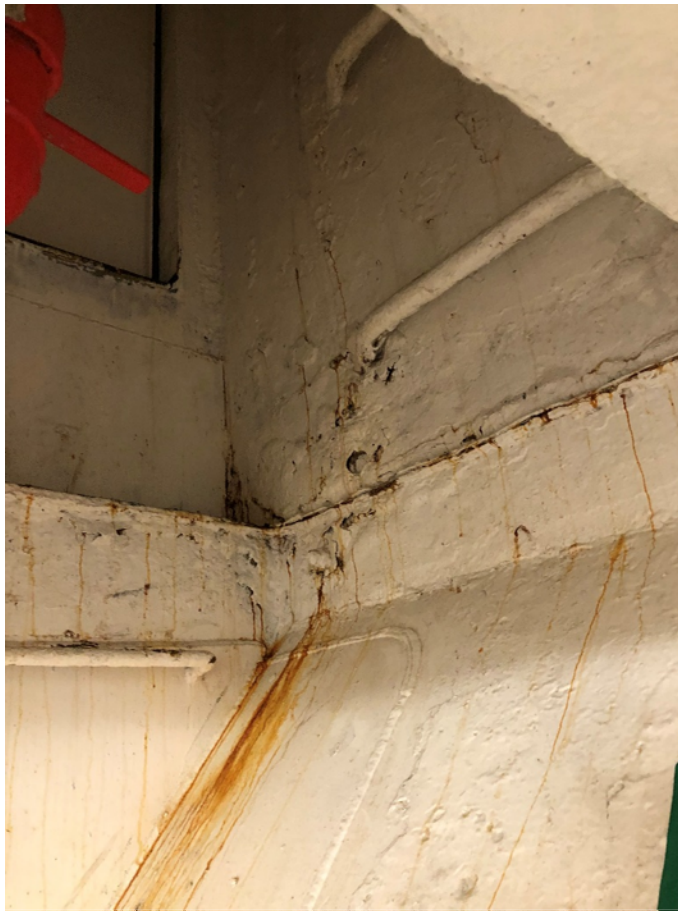
It is noted that there is significant corrosion in way of the Engine room emergency exit, with possible water ingress at the bolted connection between the wooden belting and ship side (Figure 20).

Figure 20 - Corrosion hidden under coating, in way of Engine room emergency exit

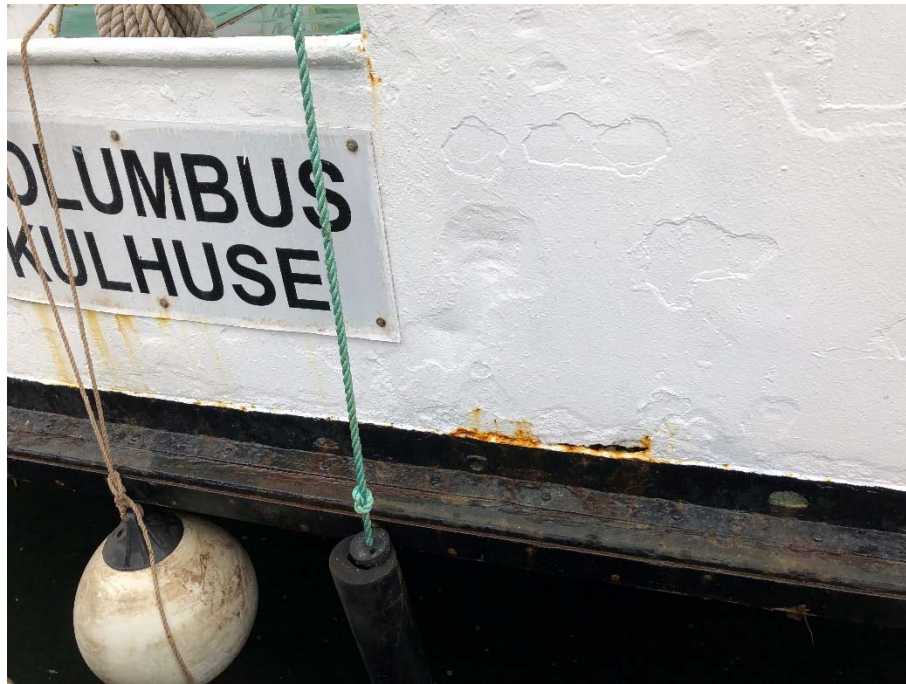
Also in Portside, in way of the life vest locker, there is a visible crack that allow water to run into the locker (Figure 21).

Figure 21 - Hole on ship side, above Deck

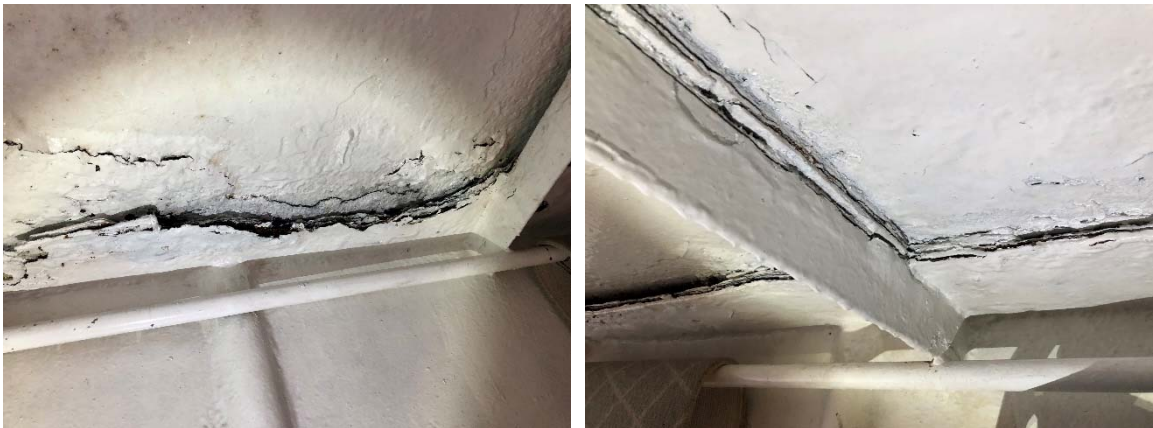
The plating on the starboard deckhouse is in poor condition. It seems that the original plating was cut around the stiffeners, and new plating added on top. It is not clear how the connection was made.

Figure 22 – Plating of deckhouse, seen from below

Therefore, it is recommended to do a more thorough investigation of the deckhouse deck plating during the next docking:

- Blast coating and corrosion;
- Perform thickness measurements;
- Replace the plating if necessary.

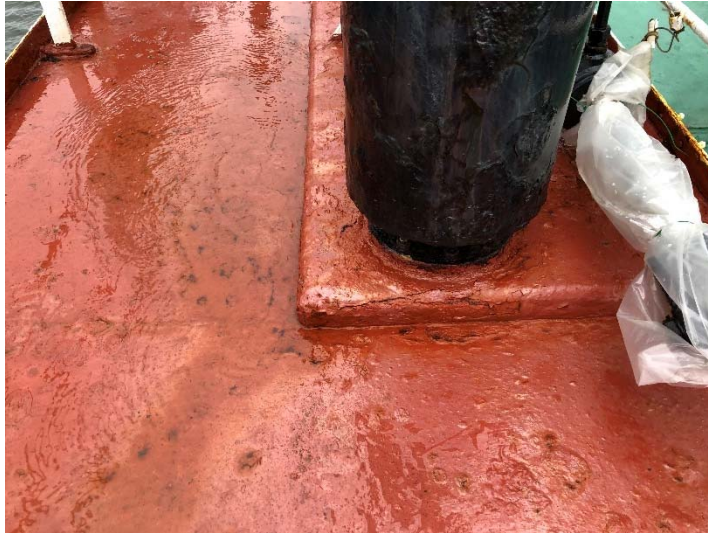
From the outside, it can be seen that the coating is in poor condition, and that rainwater is not being drained properly (Figure 23). This will lead to an increase in the corrosion rate of the plate.

Figure 23 - Plating from deckhouse, seen from above

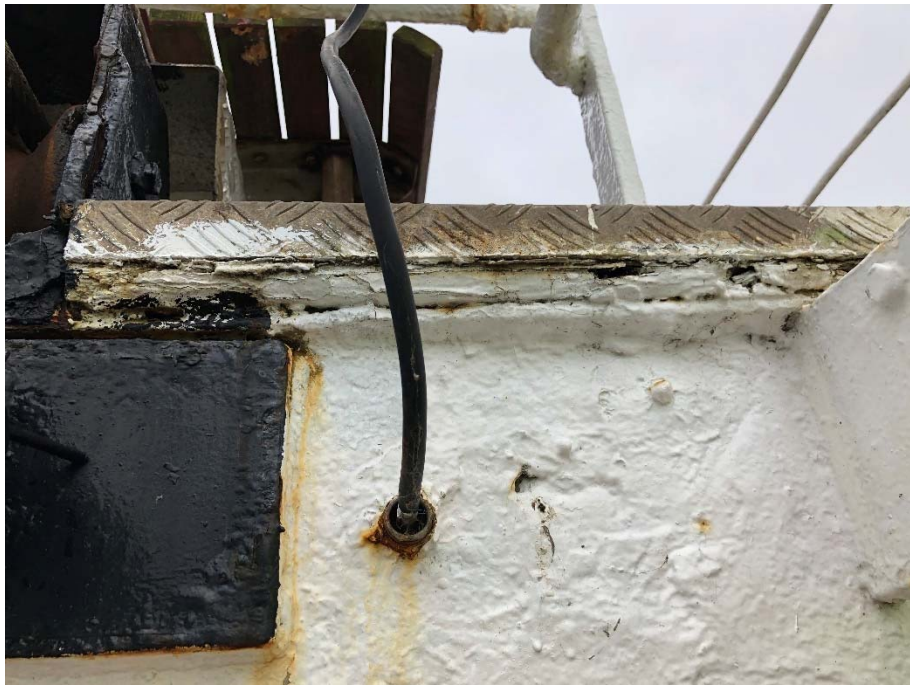
The wooden deck platform on Port side has been covered with aluminium plates. Upon analysis of the edges, it is noted that the original wooden planks are rotting (Figure 24).

Figure 24 - Passenger platform edge

It is recommended to remove the aluminium plates above the planking and the cover plates underneath the planking. If the planking is rotten, it should be replaced.

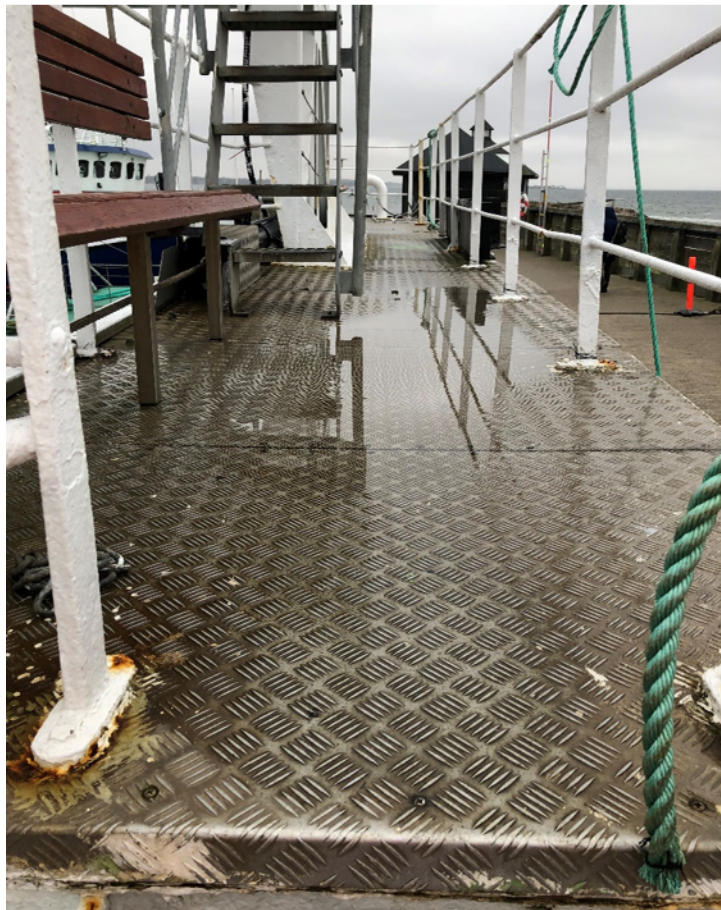
Figure 25 shows the aluminium plates installed on top of the wood planks. The plates are installed in sections, screwed into the wood. Due to poor drainage, it is likely that water is finding its way through the joints and screw holes and accelerating the rotting process.

Figure 25 - Passenger platform, presenting poor drainage

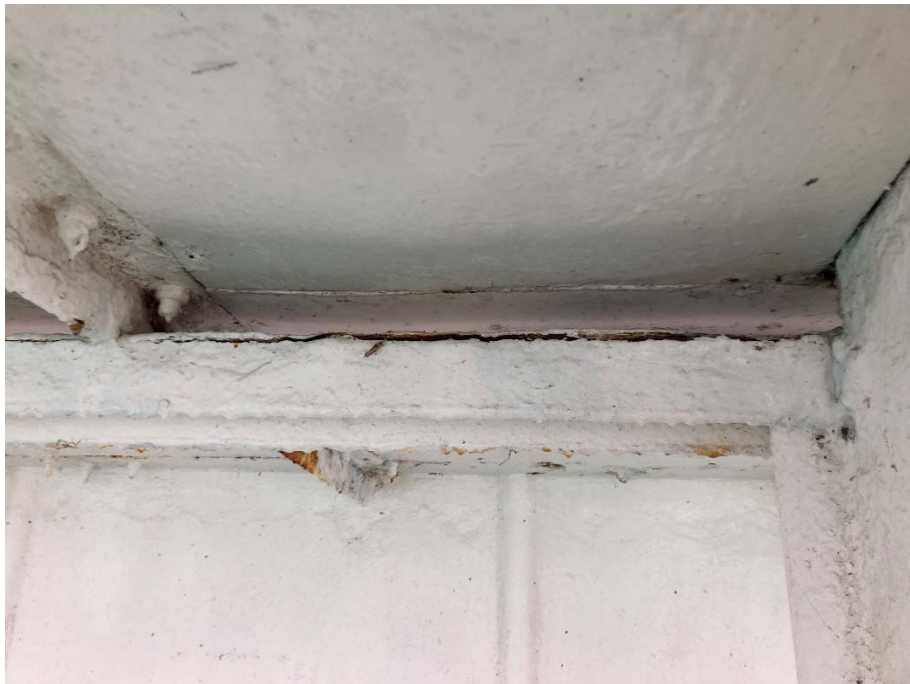
It was not possible to inspect the wooden planks from below, to assess their integrity. There is a cover plate under the deck planking (see Figure 26).

Figure 26 - Cover plate under passenger platform planking

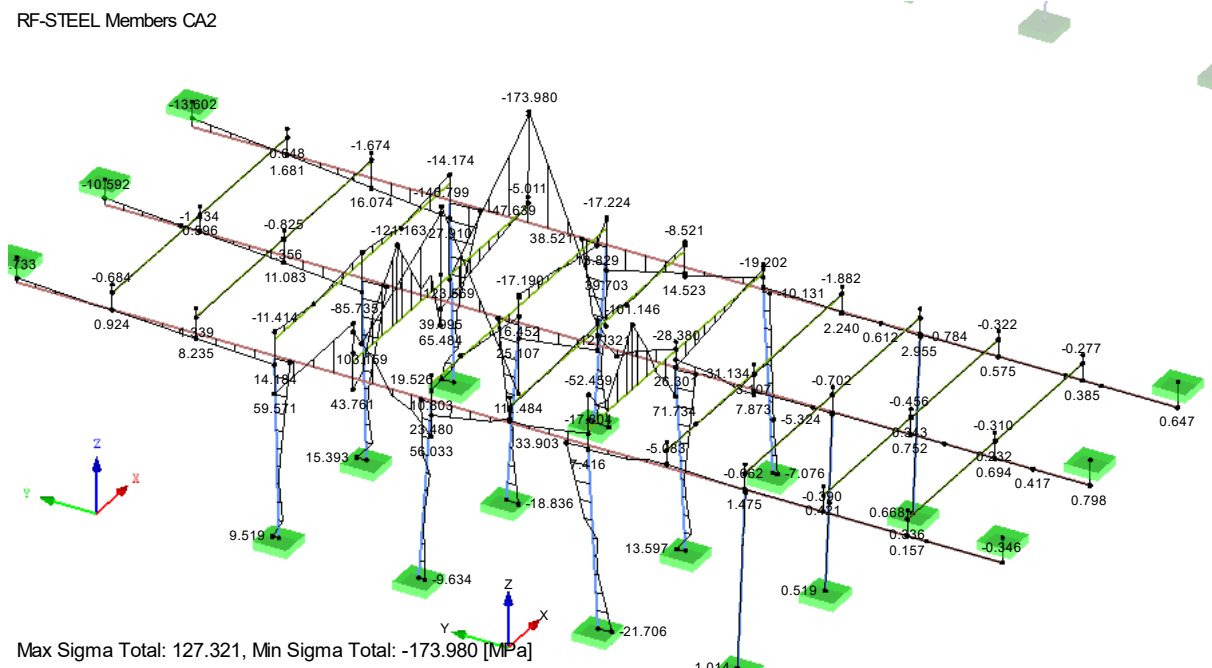
Under the loads of a light van, the deck stresses are above the allowable limit. The critical point is the midspan of the web frame, between 2 pillars. Figure 30 shows the bending stress plot for the critical load case.

Figure 30 - Plot of bending stresses under loads from a light van

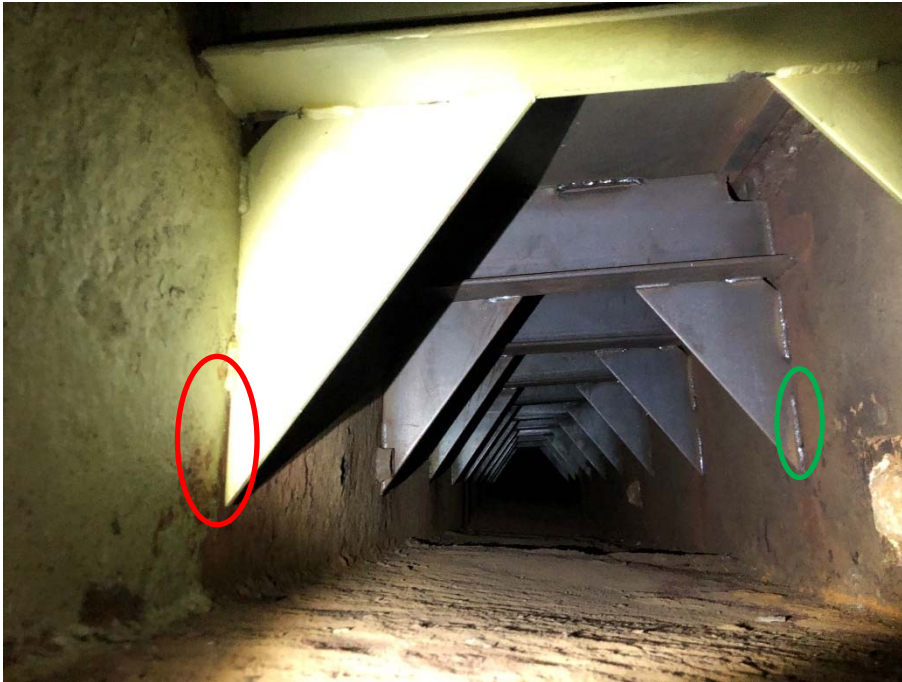
Figure 33 - Example of brackets inside old cooling water tank, with missing weld at ends (red)

-Ensure all bracket ends are welded to the base plate. Below an example of a bracket inside the cooling water tank that is not fully welded at the end (highlighted red). The bracket should be welded at both ends (highlighted green).
