M/F COLUMBUS

Vessel inspection report and Deck strength assessment

210500.01.3042.01

Date 08.02.2022
Sign TCA

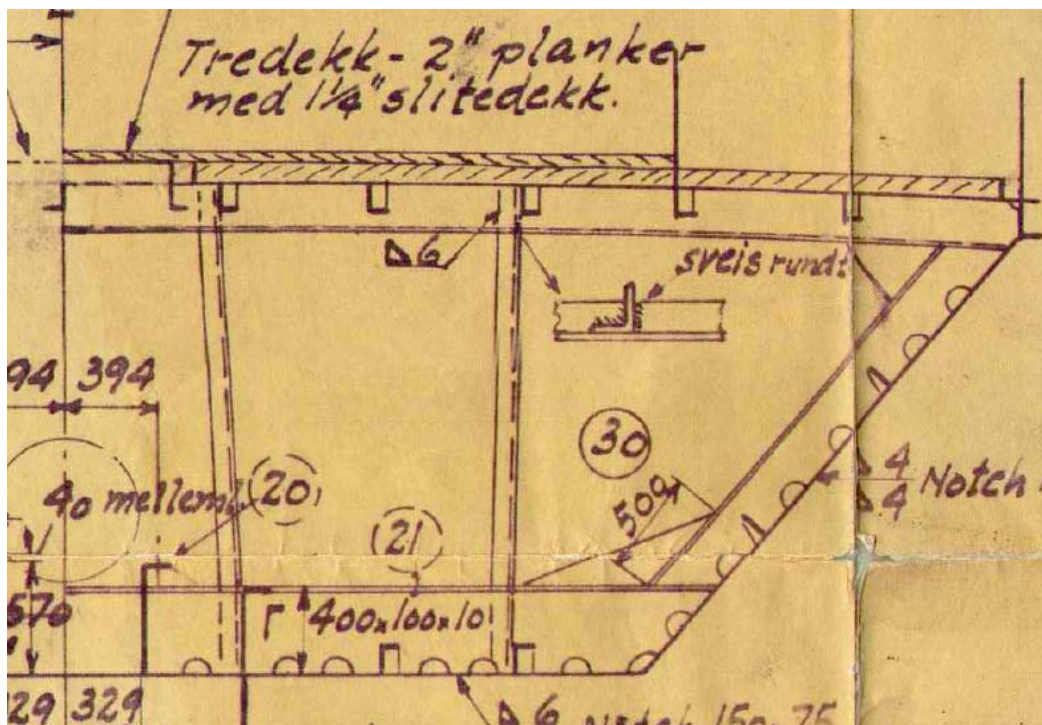
The ferry was designed with 7.0 mm deck plating, intended to be covered by a 2" wooden deck and additional wear layer.

Figure 1 - Detail of deck, from original hull drawing

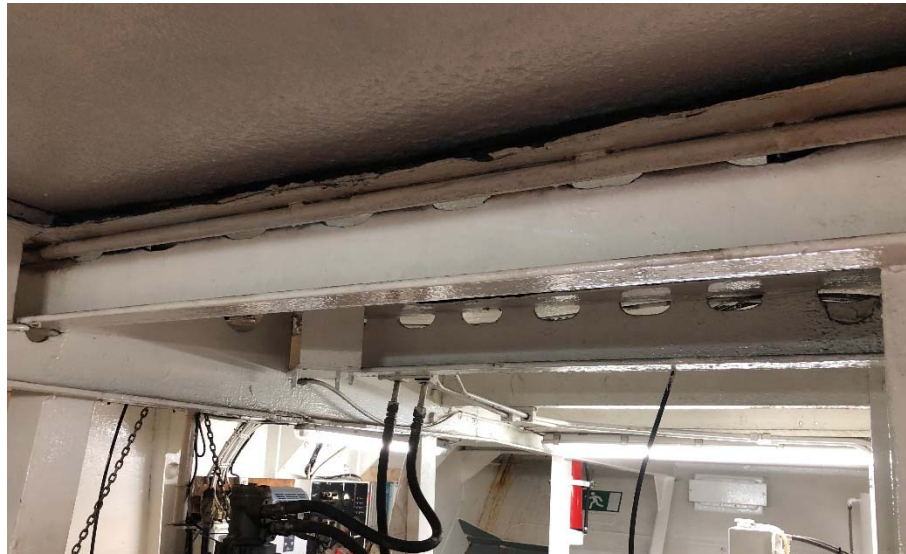
The deck longitudinals and web frames are generally in good condition, and according to original design. No flaking of the coating system has been identified.

Figure 12 - Typical condition of a deck longitudinal

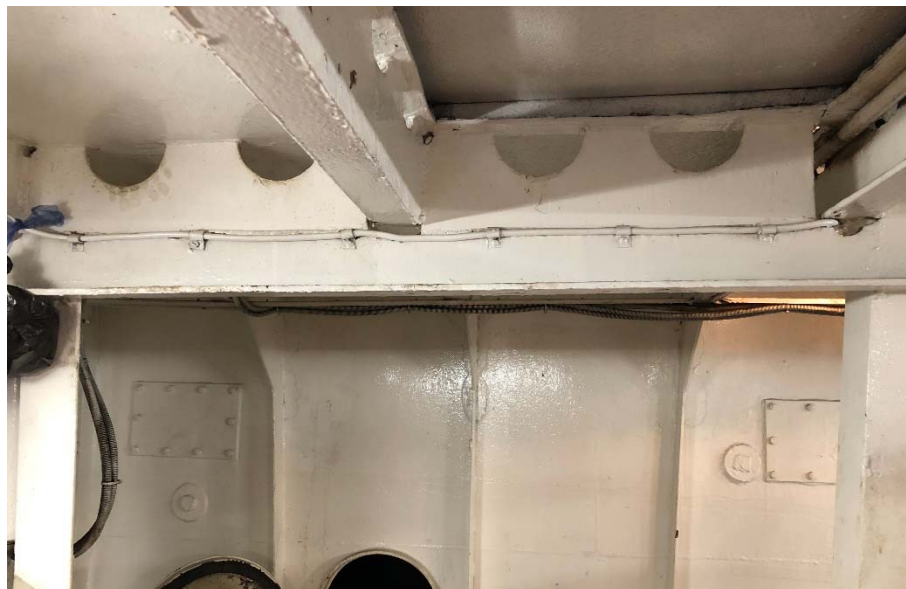
Figure 13 - Typical condition of a web frame

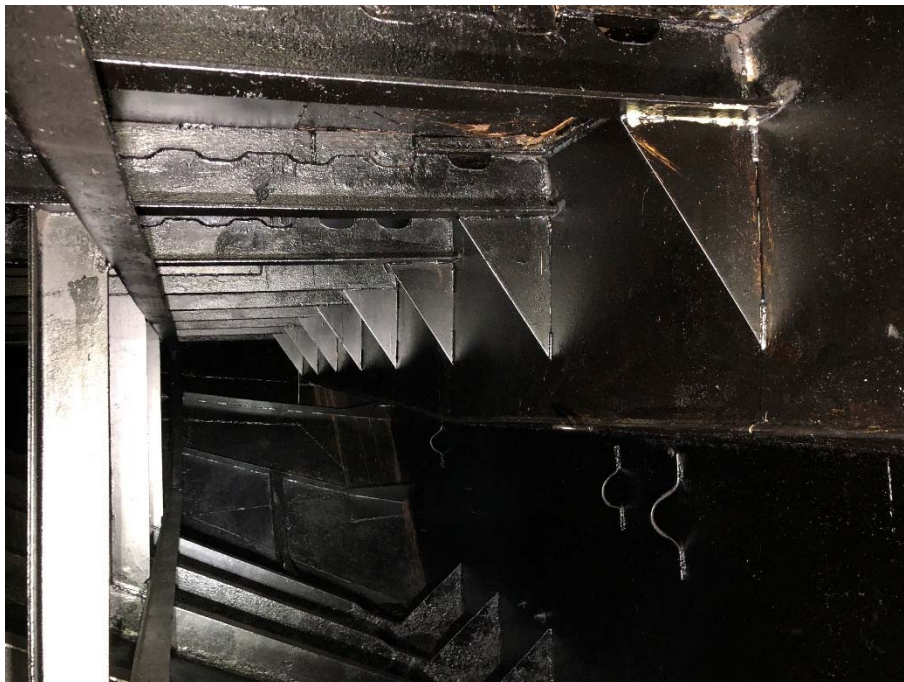
Figure 15 shows the stiffeners in the Aft void space, aft of the old cooling water tank. The original stiffeners terminate at the tank bulkhead and continue inside the tank, with a increased profile of L200x80x8 (see Figure 16).

Figure 15 - Stiffeners and flatbars in Aft void space

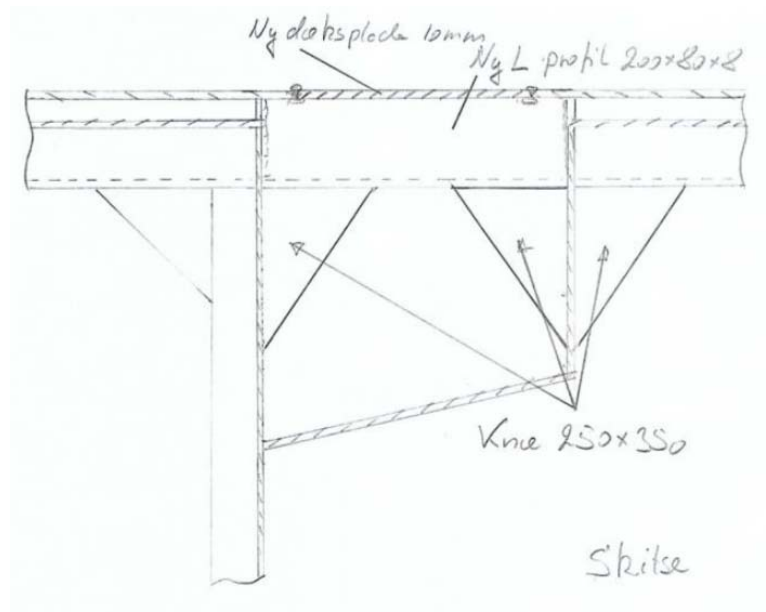
The deck longitudinal inside the MDO tank and cooling water tank were previously of a smaller profile L100x80x6.

Figure 16 – Sketch of arrangement in way of cooling water tank (Reparationsarbejde på M/F Columbus, 28/03/2020)

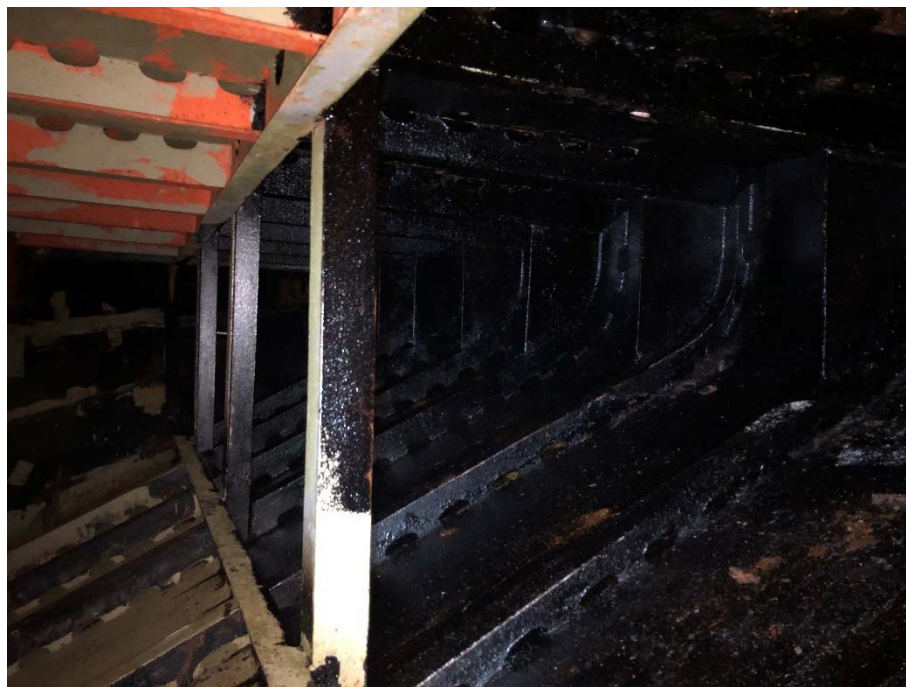
Figure 17 – Stiffeners and original deck plating in Fwd void space

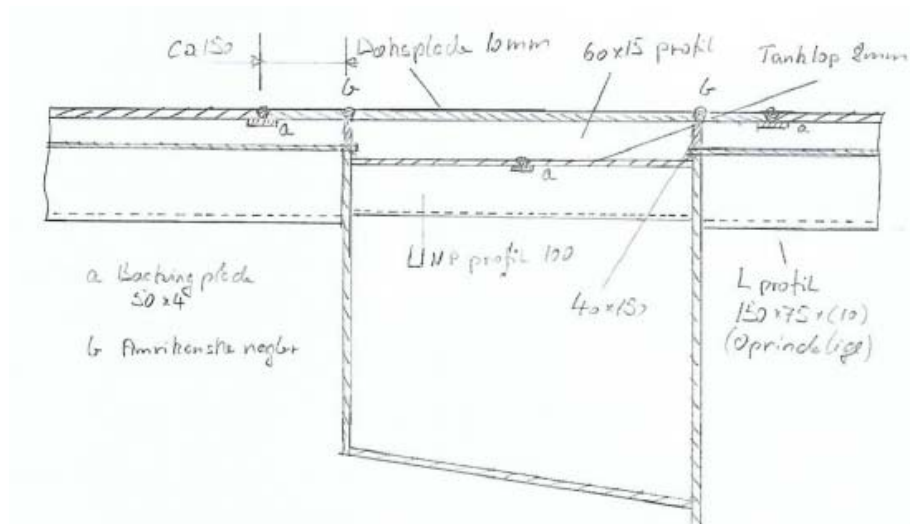
Similar arrangement is found in way of the MDO tank, but with a UPN 100 profile (see Figure 18).

Figure 18 - Modified deck structure in way of MDO tank (Udsiftning af MDO tanktop, Februar 2020)

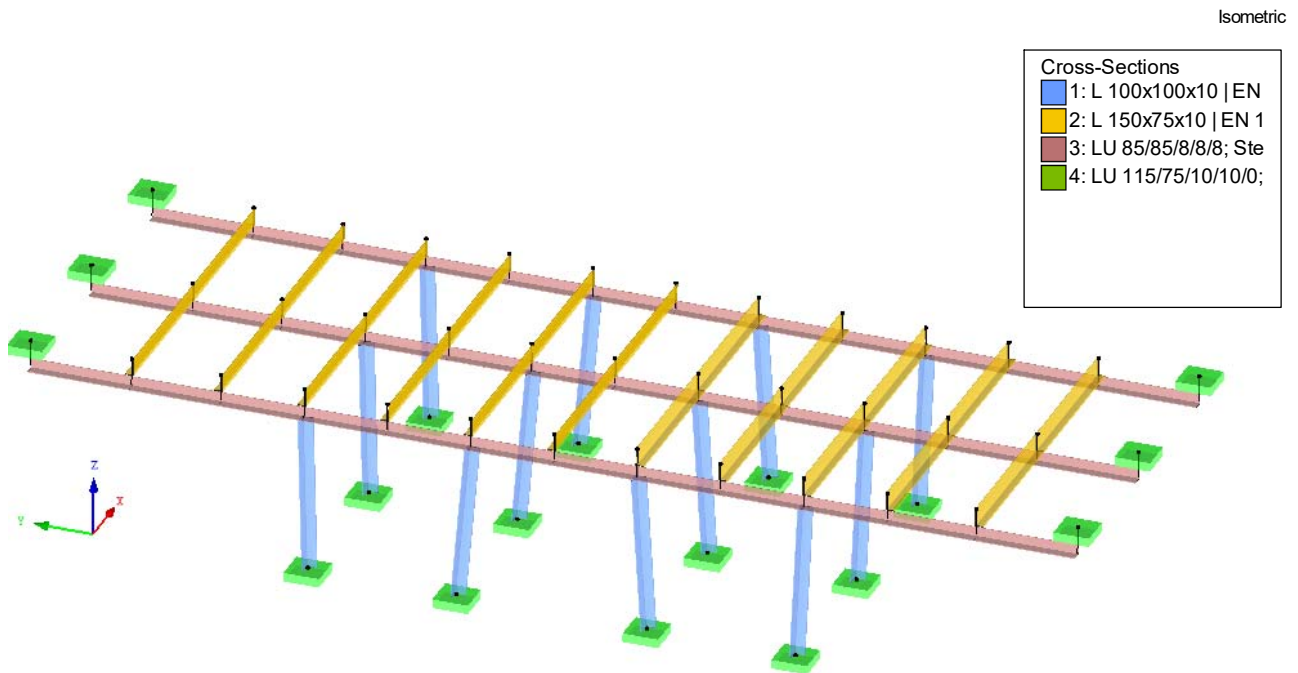
A direct calculation model of the main deck structure (Figure 27).

Figure 27 - Beam model of midship section, between 3 web frames

The beam model has been developed in RFEM (Figure 27). This model conservatively represents the deck structure in its current state. The model contains deck longitudinals, web frame and pillars between 3 arbitrary web frames. Due to its poor integrity, the original deck plating is not considered in the calculations. The deck longitudinals and web frames are defined with the cross section in way of the cut outs, as defined below.

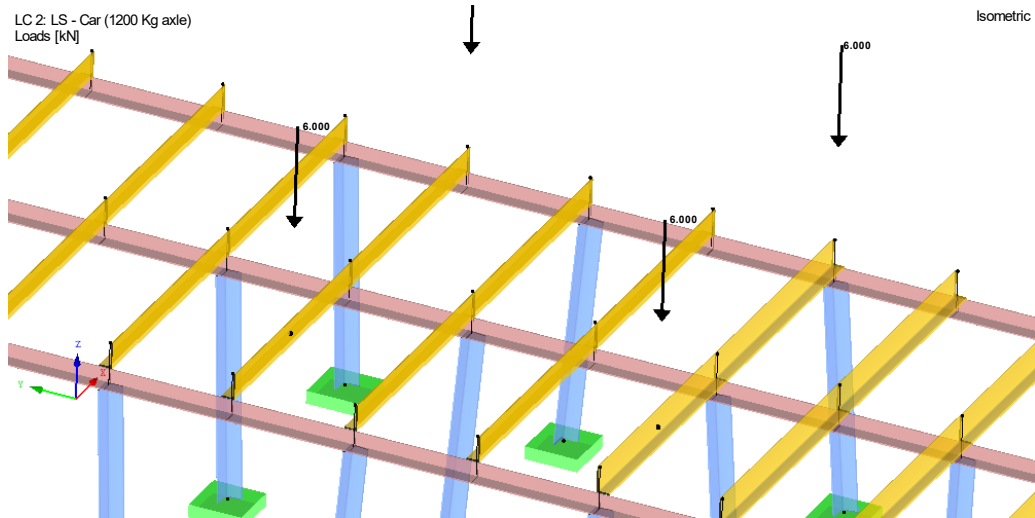
Figure 28 shows the locations where the loads are applied:

- Mid span of deck longitudinal;
- Mid span of web frame, between 2 pillars;
- Above a pillar

Figure 28 - Example of load application on deck longitudinals and web frames

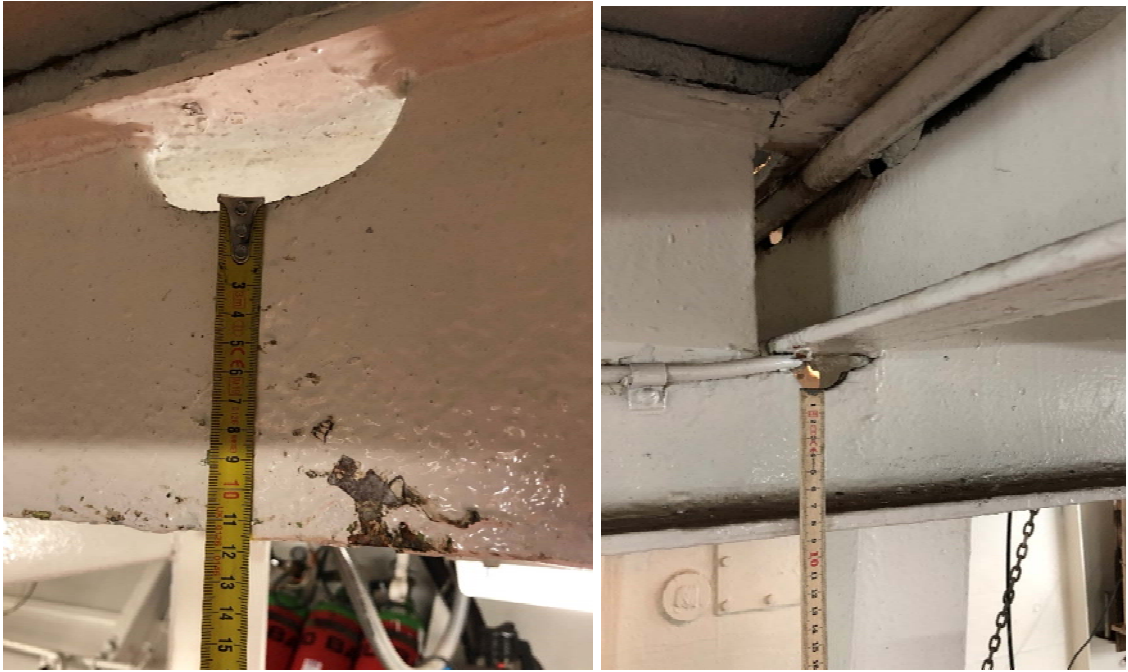
Figure 29 - Web height for stiffener (115 mm) and web frame (85 mm)

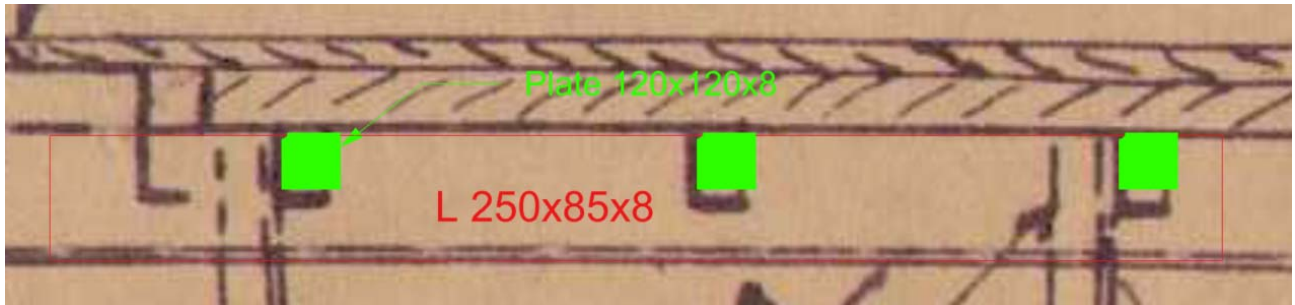
Figure 31 - Collar plates in web frame stiffener openings

In order to improve the load bearing capacity of the deck and fully utilize the cross section of the web frames, it is recommended to install collar plates in all web frame openings, as shown in green in Figure 31.

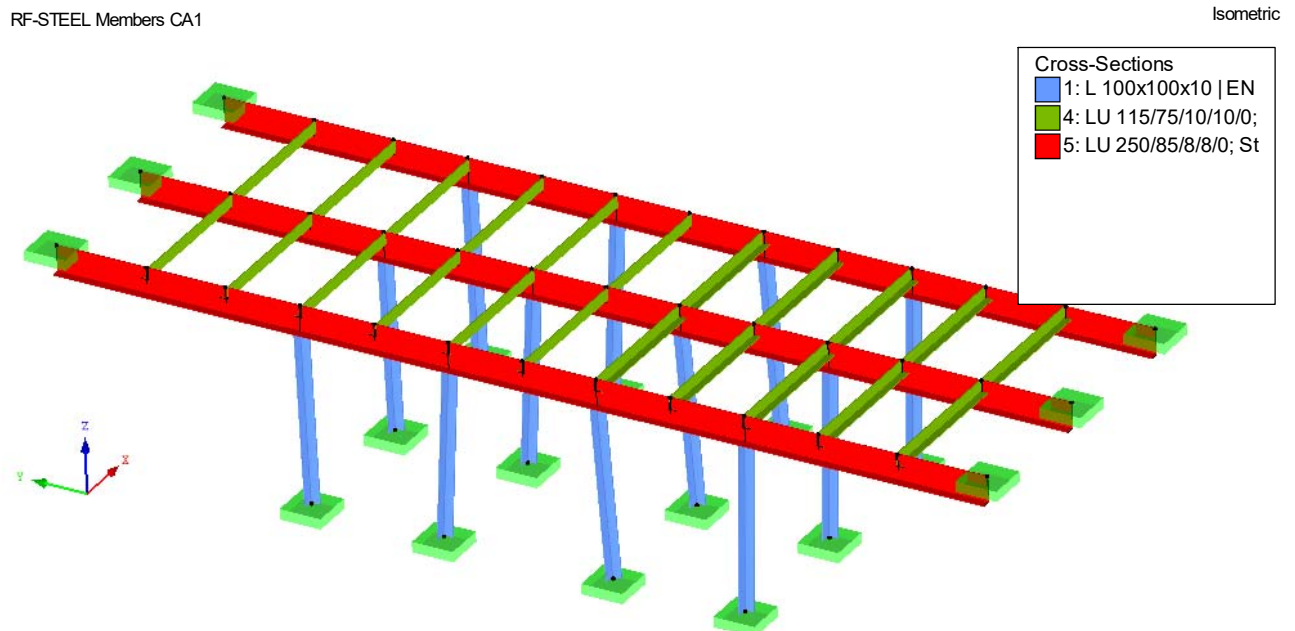
The beam model is updated to match the original web frame section properties, L250x85x8.

Figure 32 - Beam model of modified deck structure

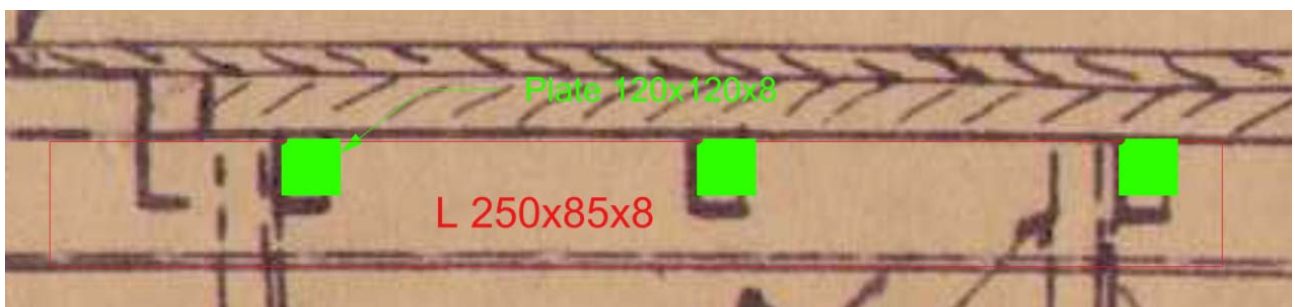
Figure 34 - Collar plates in web frame stiffener openings. Plate 120x120x8 mm

-Install collar plates in all web frame cut outs for deck stiffeners. The collars are to be welded all around, from both sides, with a weld throat thickness $a=5.0$ mm.

If this operation is performed, the maximum axle load can be increased from 2.2 ton/axle to 3 ton/axle.
